# Manhole Inspection Summary

Manhole # S27A1\_015MH

**Location** Address: **2127 ANNAPOLIS RD.**

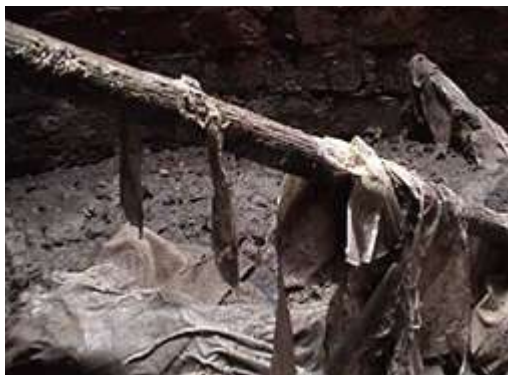
Defect 4

Condition: ☐ Sound ☐ Cracked ☐ Root Intrusion ☐ Deteriorated ☐ Leaks ☒ **Debris**

DEBRIS ONBENCH AND DEBRIS IN CHANNEL

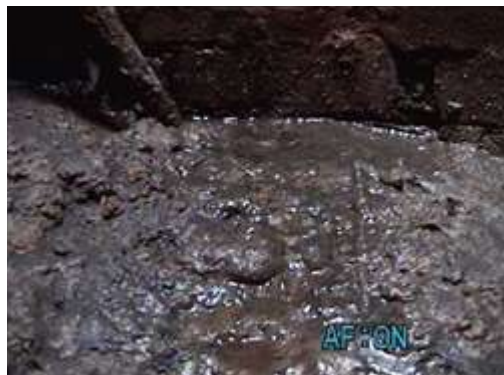
Defect 2

Infiltration: ☐ None ☐ Joint ☐ Cracks ☐ Mortar ☐ Roots ☒ **Wall**

EVIDENCE OF BARREL INFILTRATION

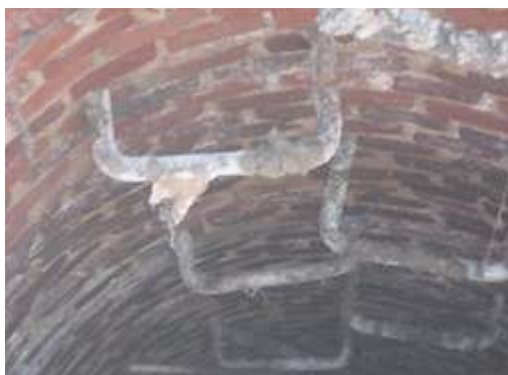
Defect 1

☒ **Evidence Of Surcharge** Depth: **9** (ft.) ☐ Active Surcharge Present

EVIDENCE OF SURCHARGE ON STEPS

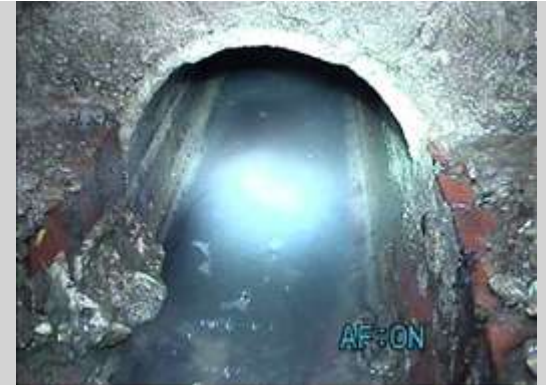
12 O'Clock Outflow

12 in. Circular Gravity Sewer  
Pipe Out @ 12 O'Clock

Pipe Height: **12** (in.) Rod and Bar (Angled)  
Pipe Material: **Clay** ☐ Pipe Lined  
Invert Depth: **13.60** (ft.) Flow Characteristics: **Fast**  
Deposits: ☐ None ☐ Mud ☐ Sludge ☒ **Debris** ☐ Grease  
Silt Depth: **4** (in.) Deposits Extent: **Medium**  
Infiltration: **Evidence** Pipe Seal Cond: **Unknown**

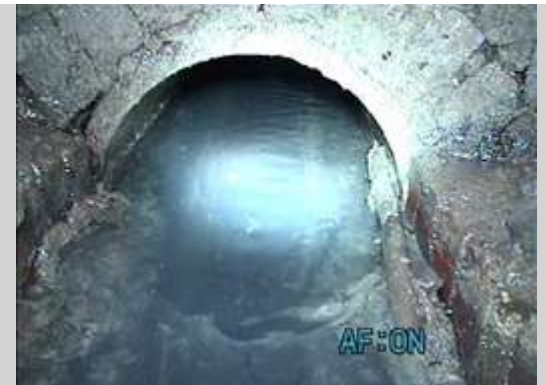
9 O'Clock Inflow

12 in. Circular Gravity Sewer  
Pipe In @ 9 O'Clock

Pipe Height: **12** (in.) Rod and Bar (Angled)  
Pipe Material: **Clay** ☐ Pipe Lined  
Invert Depth: **13.56** (ft.) Flow Characteristics: **Fast**  
Deposits: ☐ None ☐ Mud ☐ Sludge ☒ **Debris** ☐ Grease  
Silt Depth: **6** (in.) Deposits Extent: **Medium**  
Infiltration: **Evidence** Pipe Seal Cond: **Unknown**
